| Title 184-B Powerhouse, 184-D Powerhouse, 1717-F Maintenance Shop Facility Decommissioning Report | Number SD- DD-TI-033 | Rev. No. 0 | Page A |

This report documents the final site cleanup of the previously decommissioned 184-B Powerhouse, 184-D Powerhouse, and 1717-F Maintenance Shop. The report includes the three site cleanup projects because their like-work effort and contiguous FY 88 work schedule. The site projects started in January 1988 and were completed in April 1988.

FACILITY DECOMMISSIONING REPORT

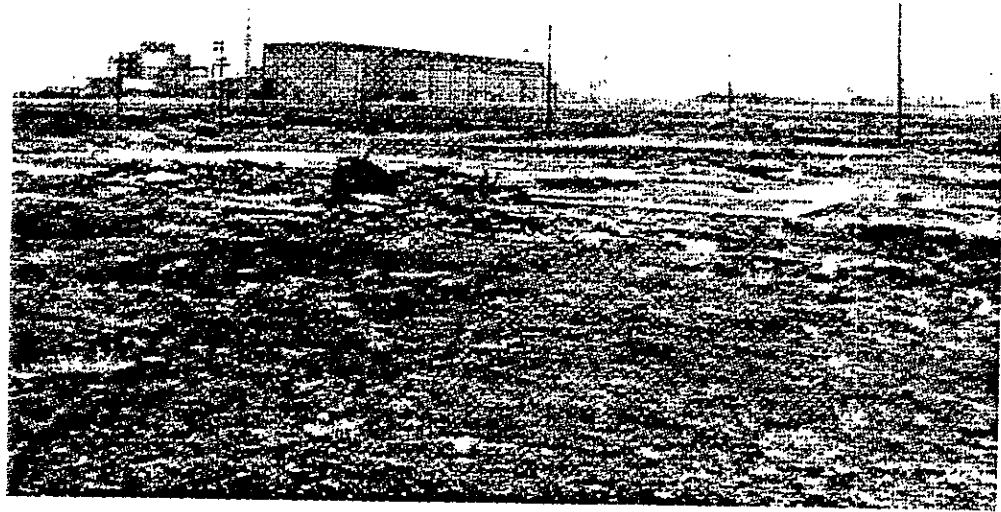
Figure 6. Before (Top) and After (Bottom) Final Site Cleanup on the 184-B Powerhouse Site.

The previous excessing demolition program left the powerhouse foundation slabs, footings and several associated concrete structures intact. The foundation slabs were exposed, with concrete equipment mounts rising 1 to 3 ft above the main slabs. The 184-D three massive stack bases were left intact. The general area was littered with demolition rubble.

Figure 6 (184-B site), Figure 7 (184-D site), and Figure 8 (1717-F site) shows the status of the facilities area before and after final site cleanup.

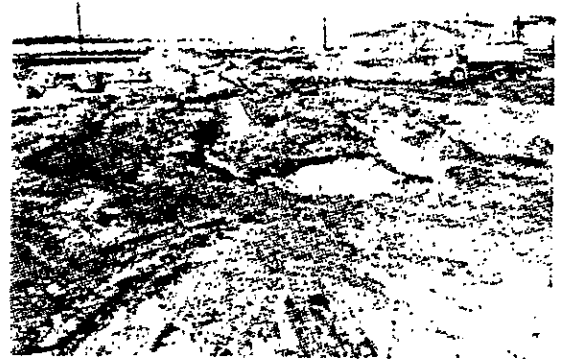
2. Excavation for demolition of tunnel walls and roof.

Figure 10. Final Site Cleanup of a Typical Coal Facility (184-D Site).
